EXPERT REPORT
OF
DAVID J. ERICKSON

Community Association for Restoration of the Environment, Inc.
and Center for Food Safety, Inc.,

Cow Palace, LLC

(E.D. Wash. No. CV-13-3016-TOR)

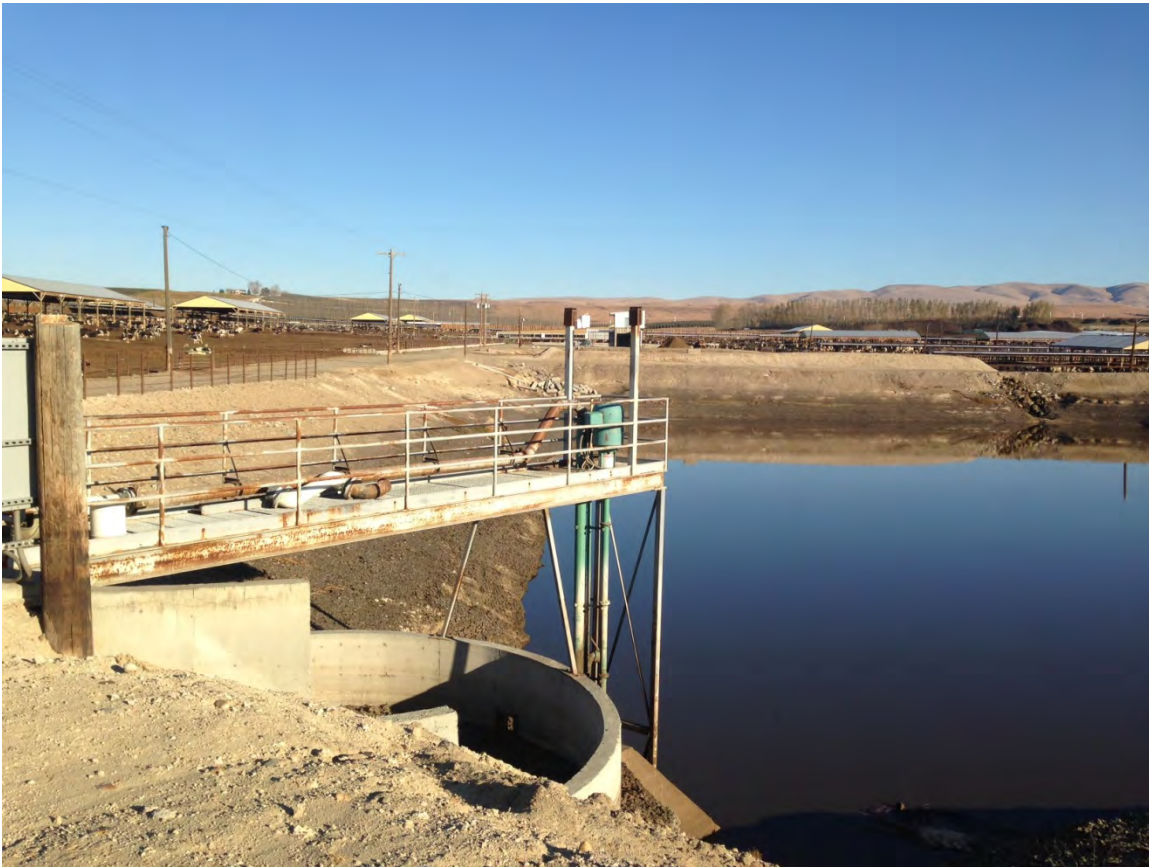
Photo: View to northeast of Lagoon 1. Erosion caused by Settling Basins discharging into Lagoon 1 is visible in background.

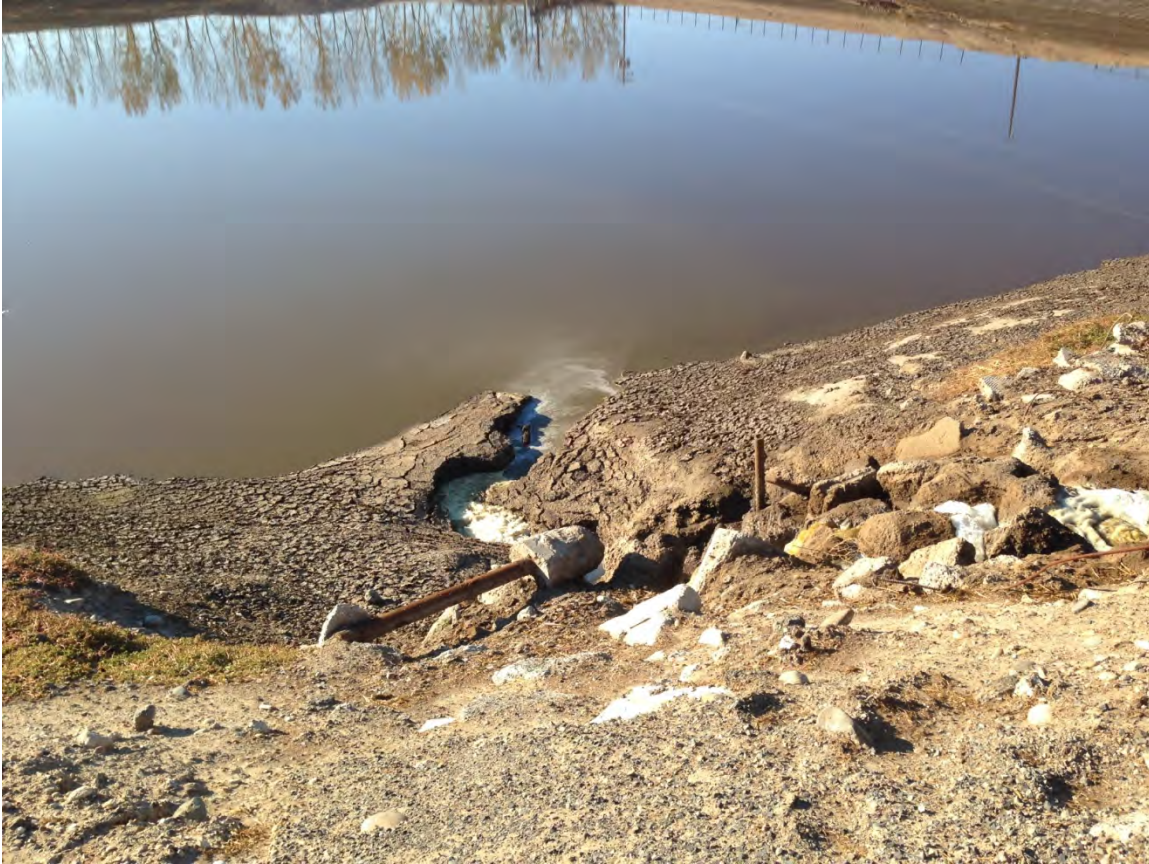
Photo: View to southwest of Lagoon 1. Dried, cracked, and eroded manure seal is visible in foreground.

51. Visible in the photo is the desiccation of the manure seal and the erosion of the manure down to native soil wherever water is discharged into the lagoons.

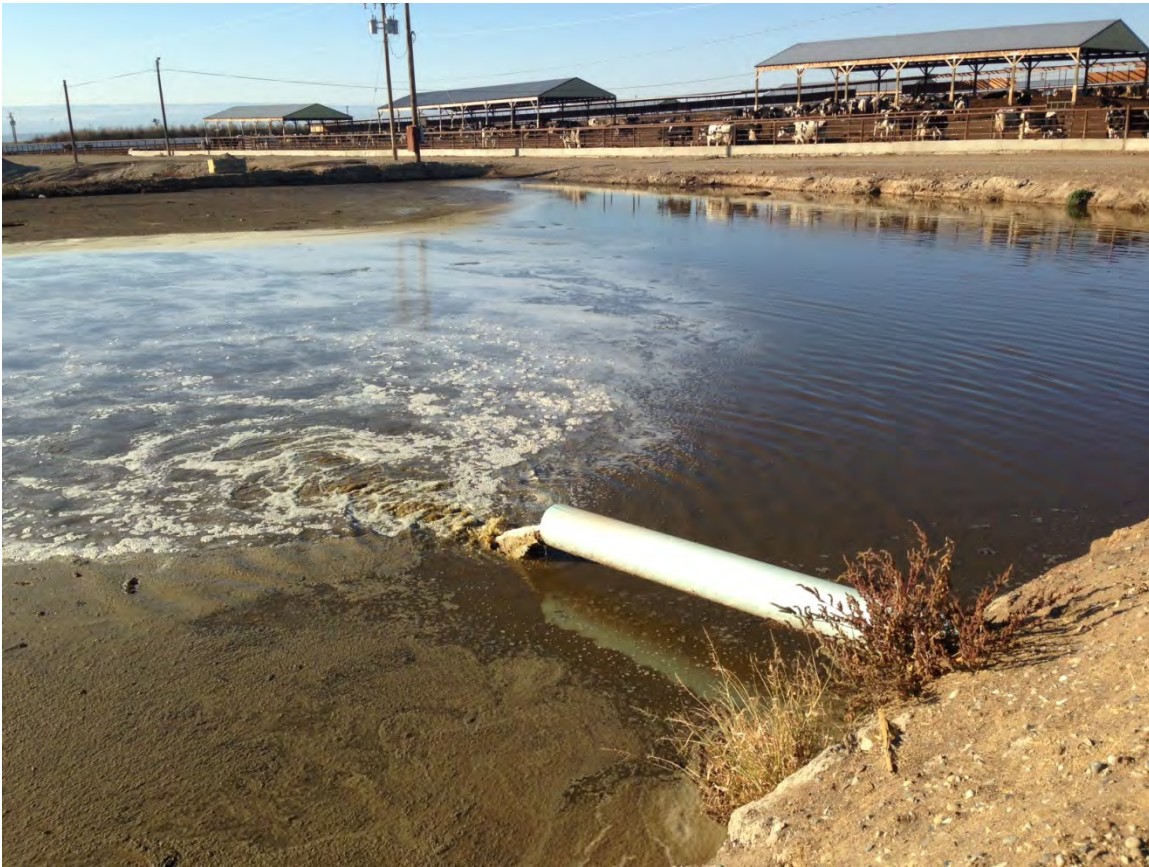
Photo: View to southwest of west Settling Basin. Waste being discharged from collection sump is visible in foreground.

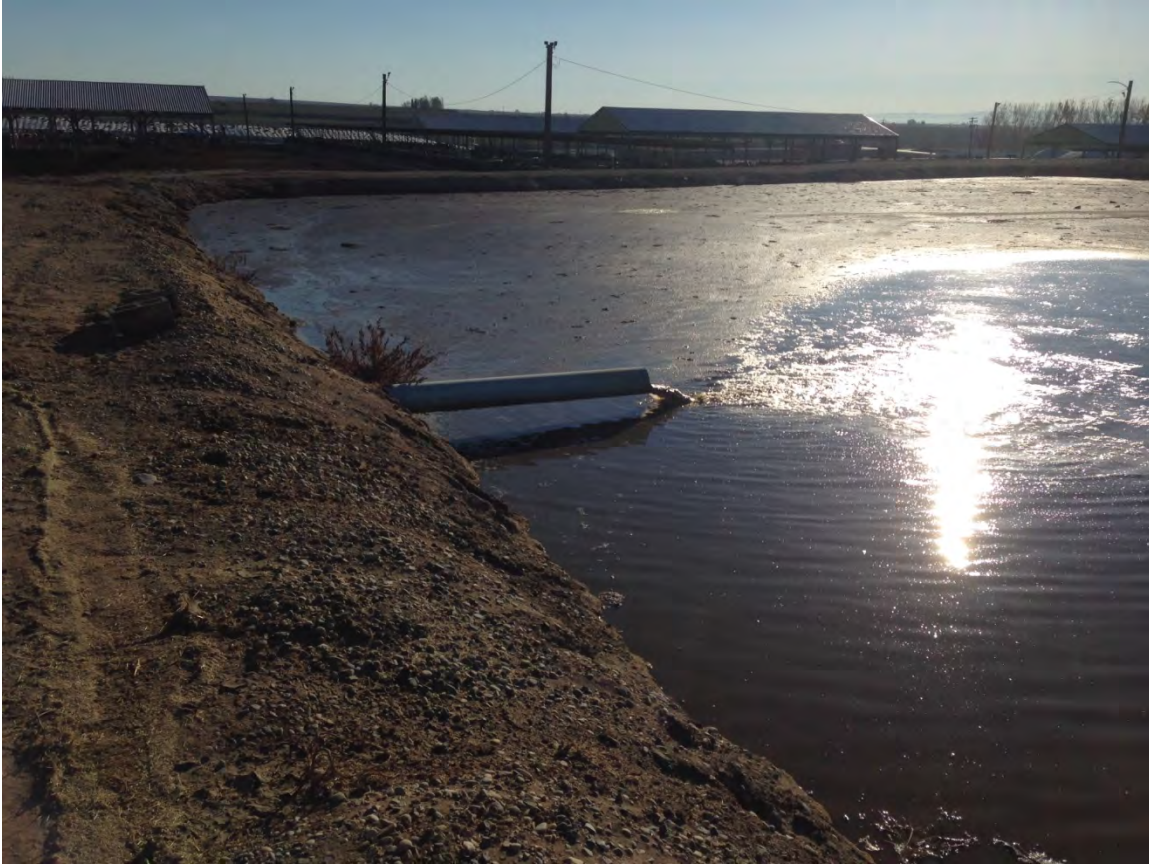
Photo: View to southeast of east Settling Basin. Waste being discharged from collection sump visible on north end of basin.

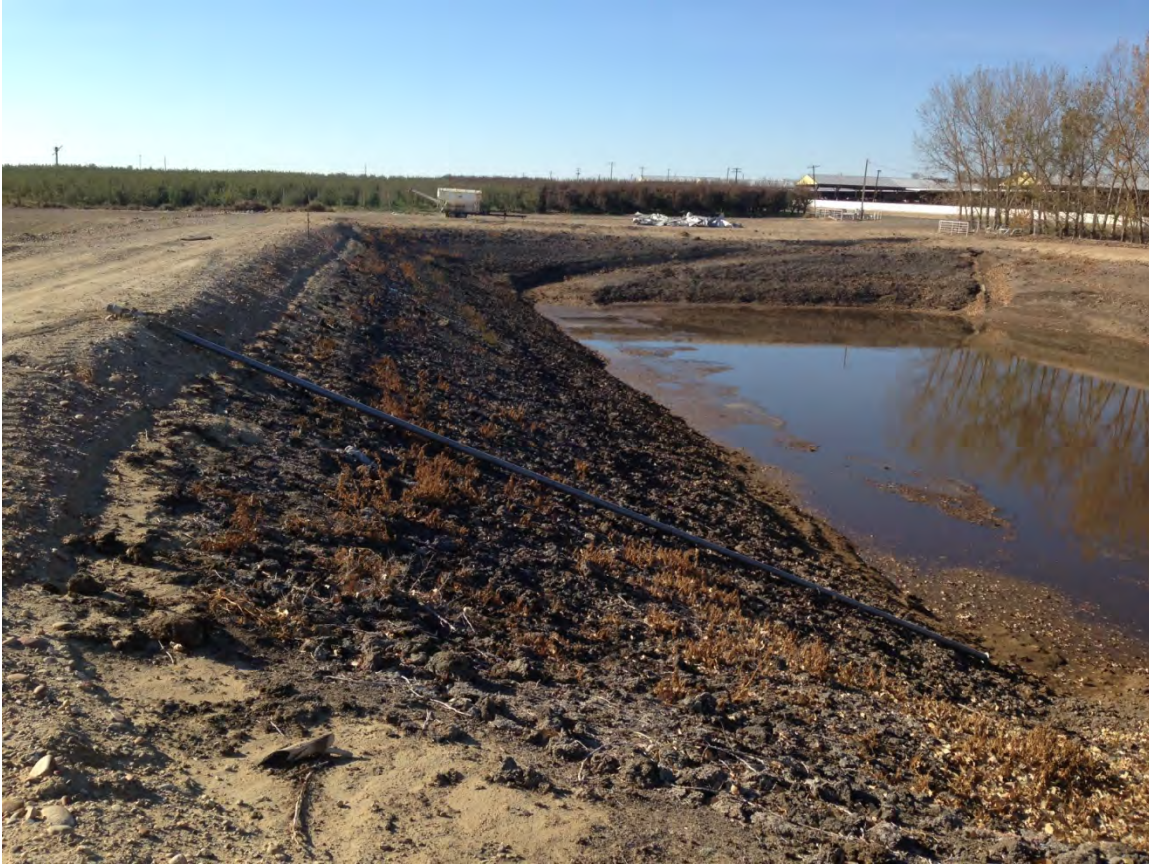
Photo: View to the west of Lagoon 2. Dried and cracked manure seal on sloped sides of lagoon is visible on south end of lagoon.

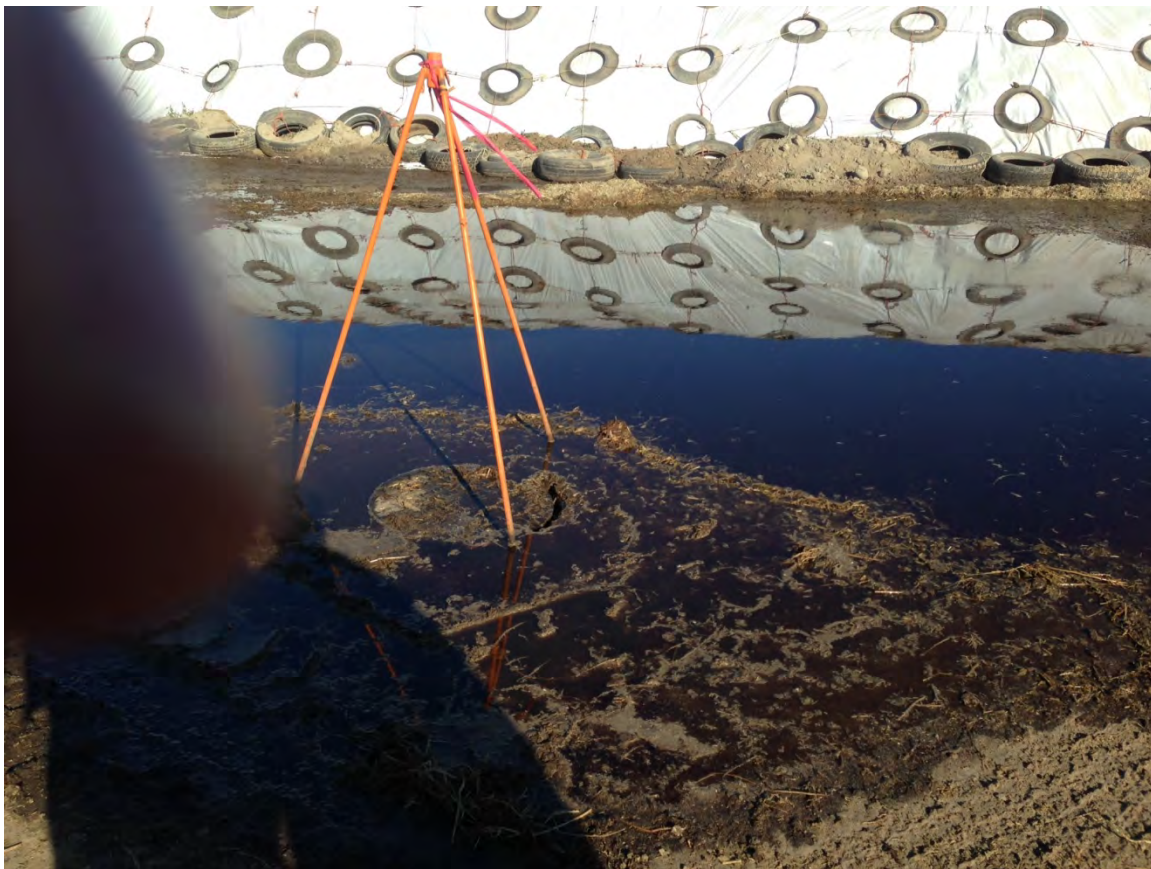
Photo: View during October 2013 inspection of drop inlet near Safety

Debris Basin collecting silage leachate. Leachate was being conveyed through a pipe and discharged into Safety Debris Basin.

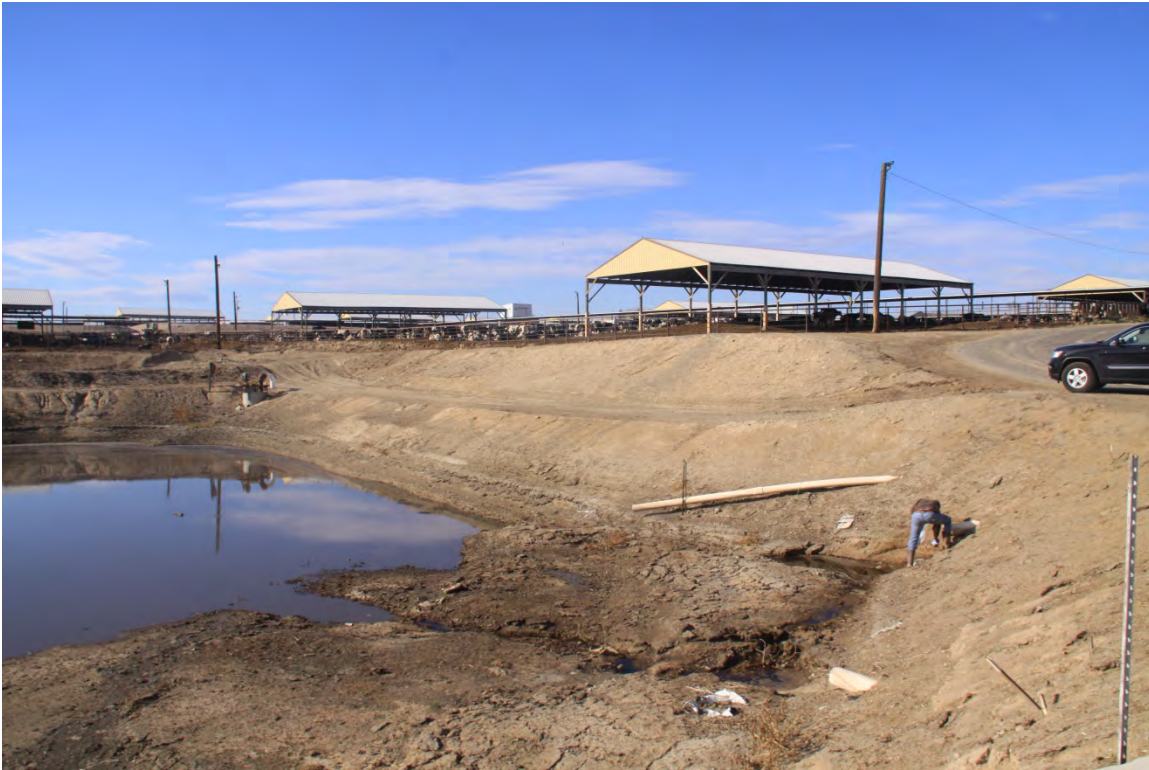
Photo: View during October 2013 inspection of Safety Debris Basin. A sample of silage leachate being discharged into the basin is being collected at right.

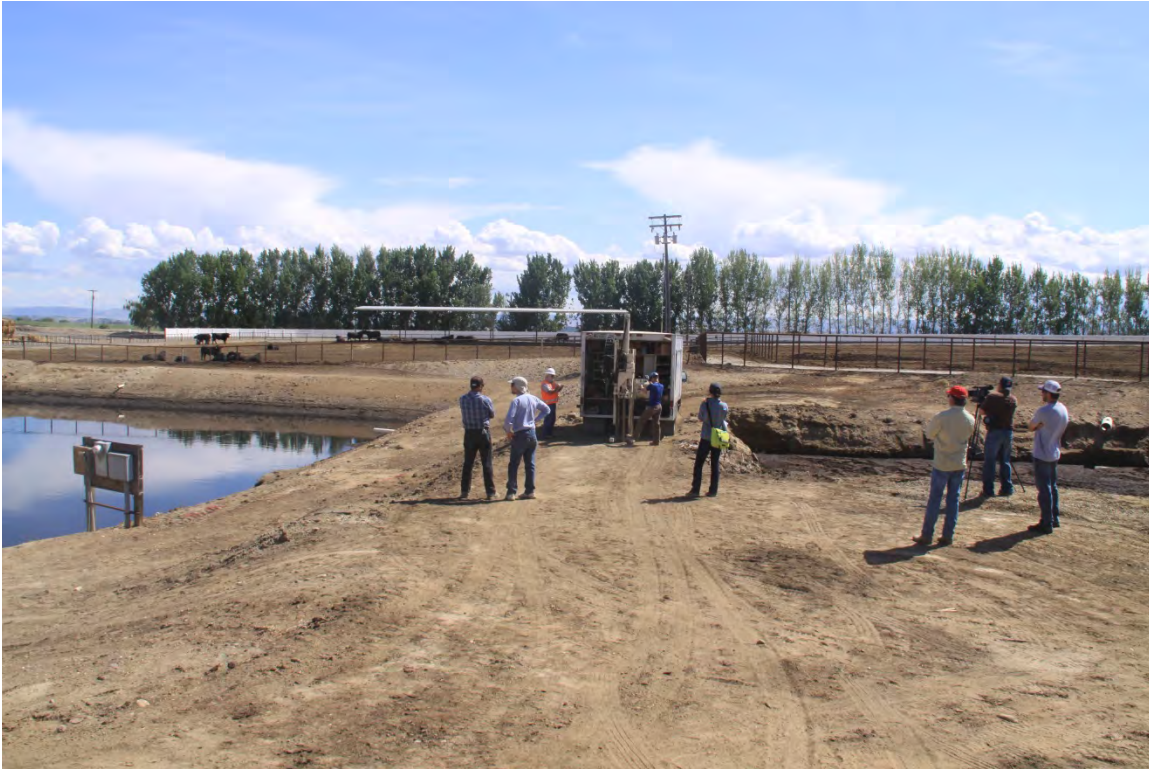
Photo: View to south during May 2014 inspection. Safety Debris Basin visible at left and storm water catch basin at right.

83. There is no question that Safety Debris Basin and the adjacent stormwater catch basin discharge liquid into the ground.

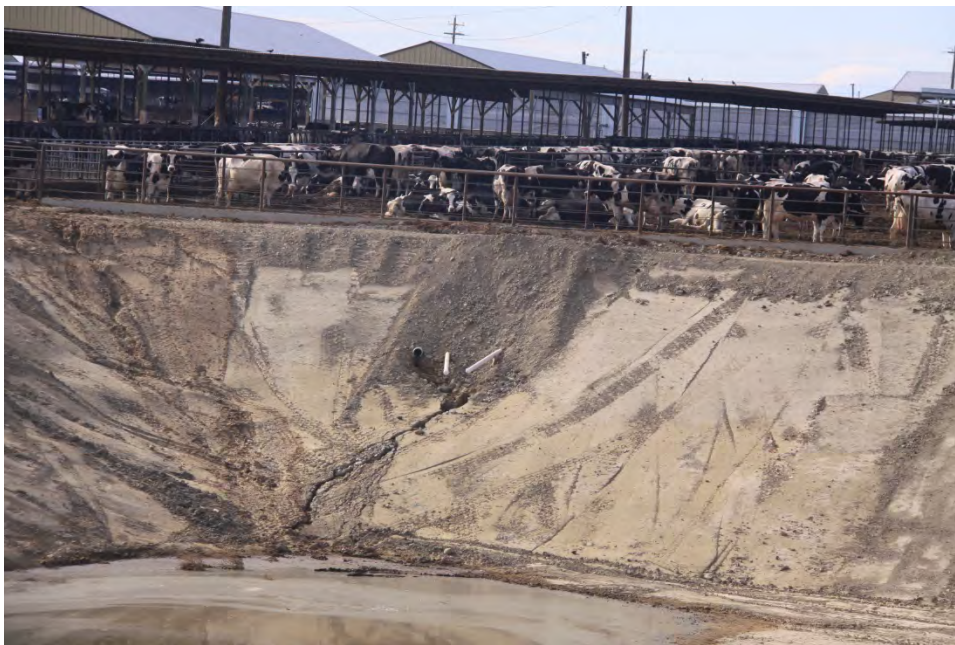
Photo. View of NW Catchment Basin during October site visit. New liner with significant erosion from infall pipes is shown

92. The photos above represent the condition of the Catch Basin NW as it was at the time of Plaintiffs' October 2013 inspection. As is evident from the photographs, Cow Palace had recently completed re-sloping the sides and compacting the soil liner.

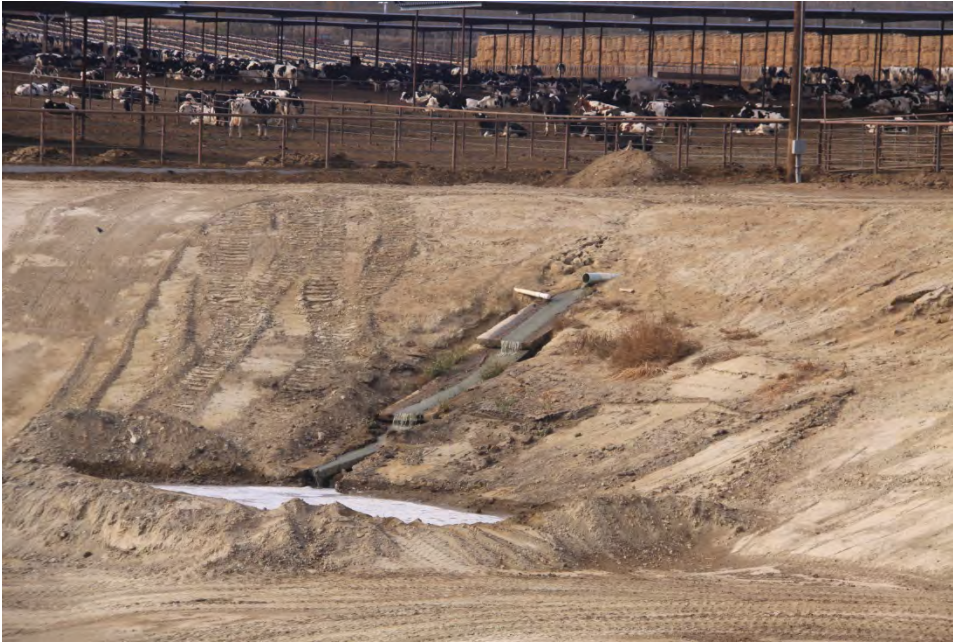
Photo. View of NW Catchment Basin. Outfall from calf pens with liquid infiltrating is shown.

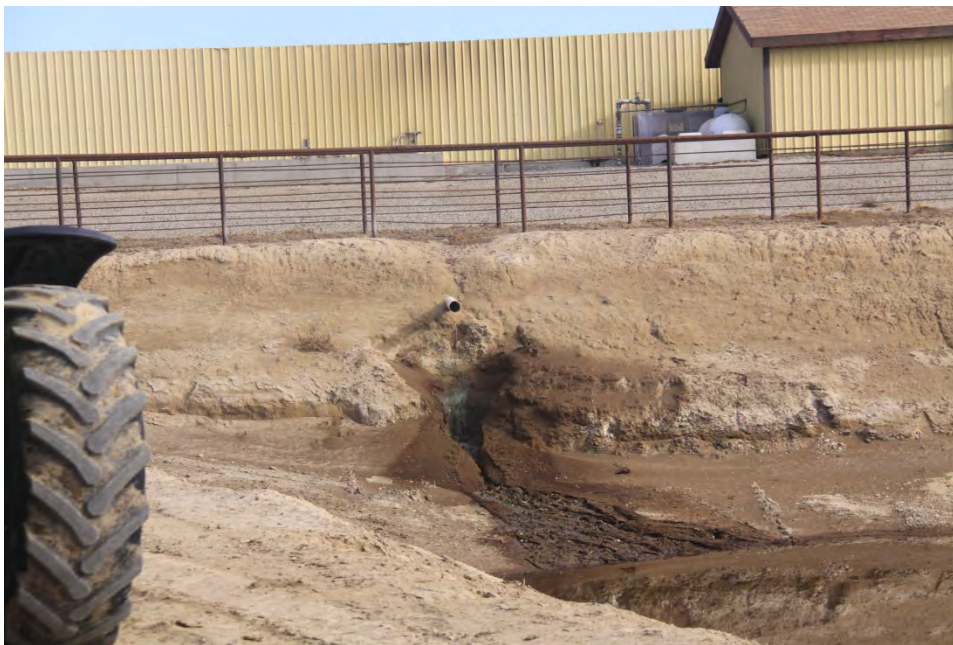
Photo. View of NE Catchment Basin. Note erosion from inflow and lack of manure seal.

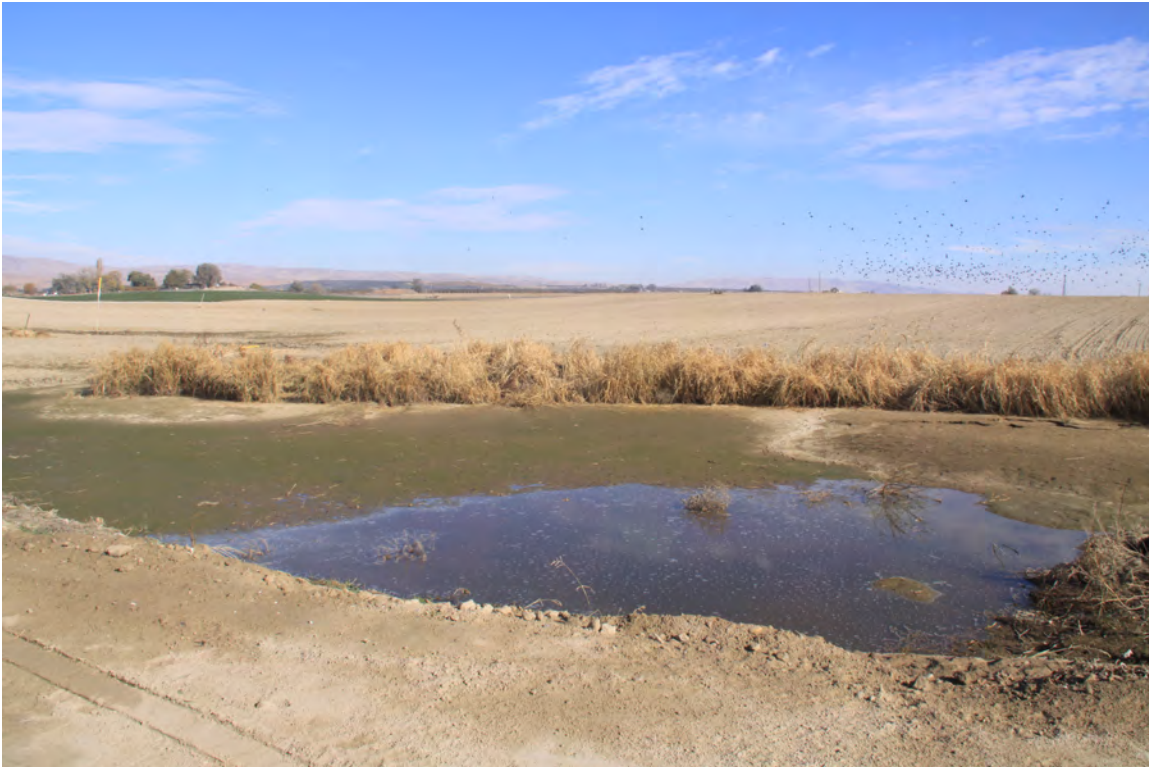
Photo. Tailwater pond adjacent to Liberty

105. There is no question that the tailwater recovery ponds discharge manure-contaminated water into the ground. The concentration of the

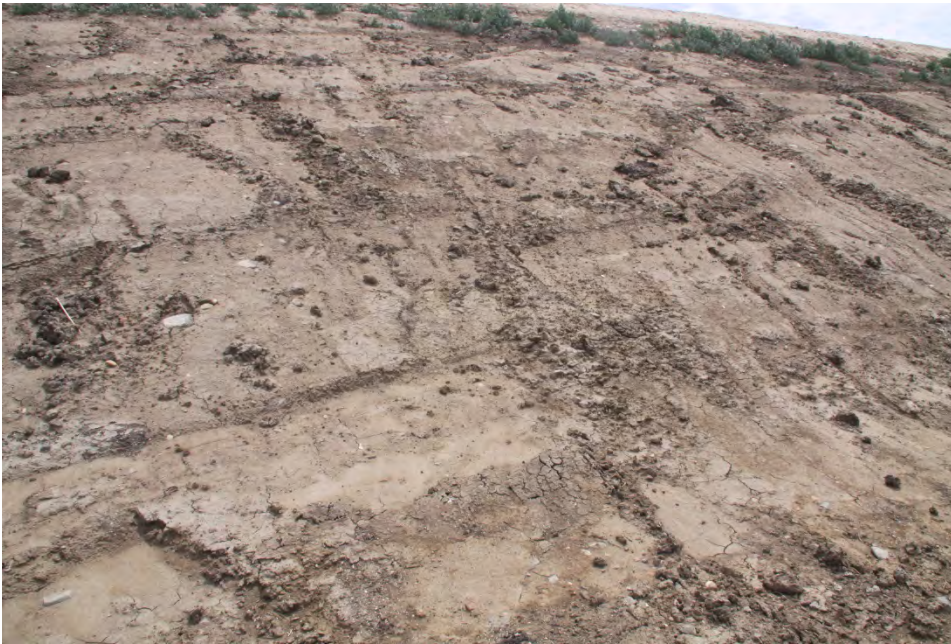
Photo: Side of Haak Lagoon with manure cake and native soil exposed. Note gravel and cobbles.

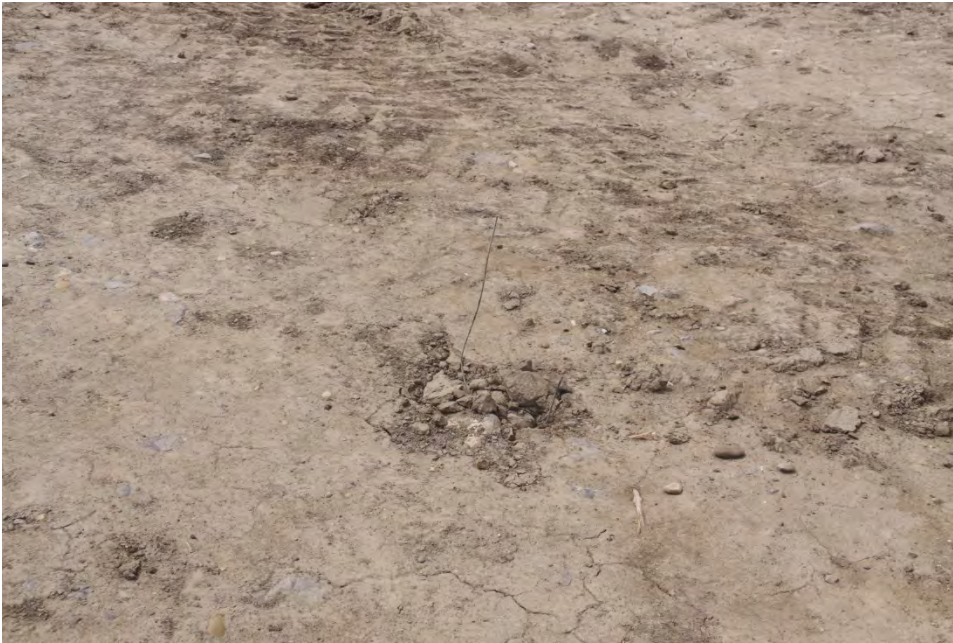
Photo. Bottom of Haak lagoon with native soil and wire.

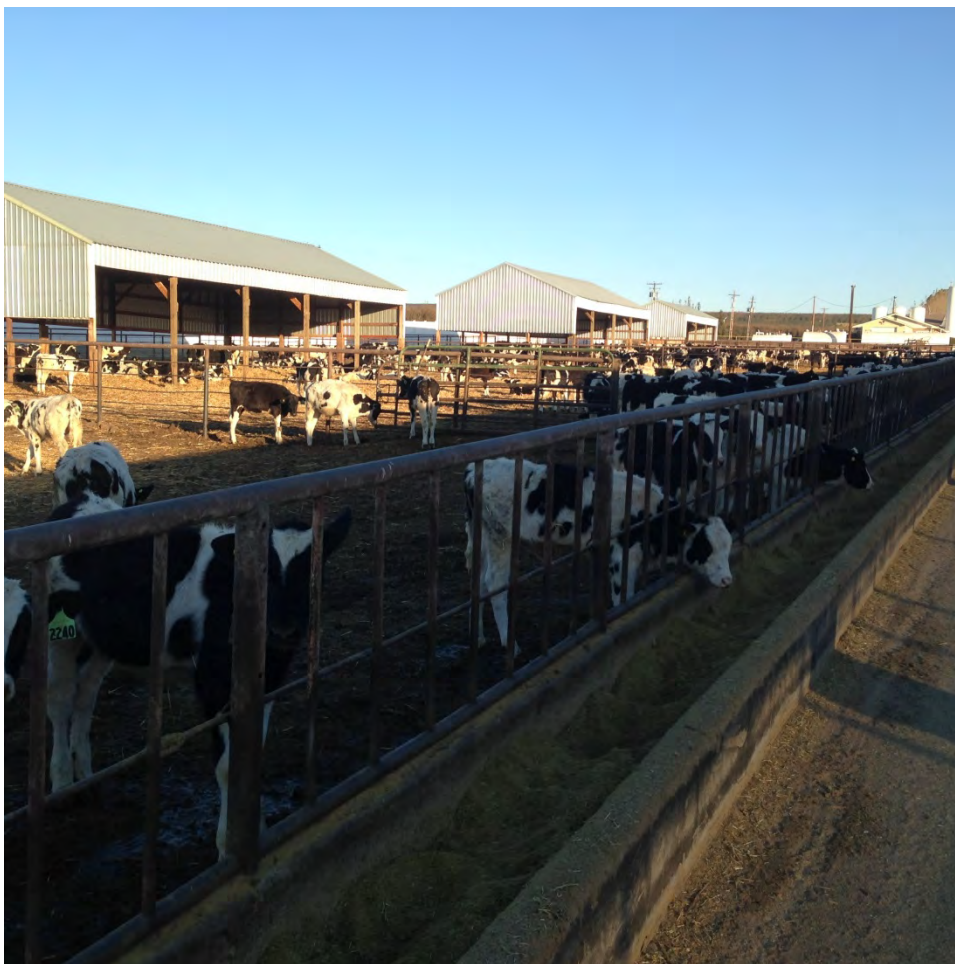
Photo. Note pooled liquid at bottom left.

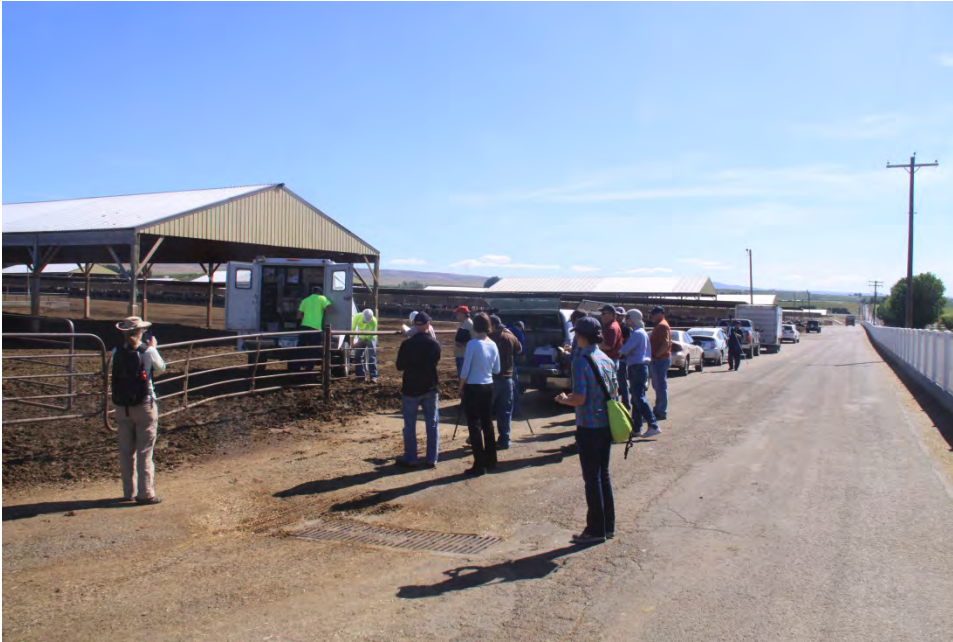
Photo: View of Cow Palace holding pen during May 2014 inspection. Note saturated manure and soil.

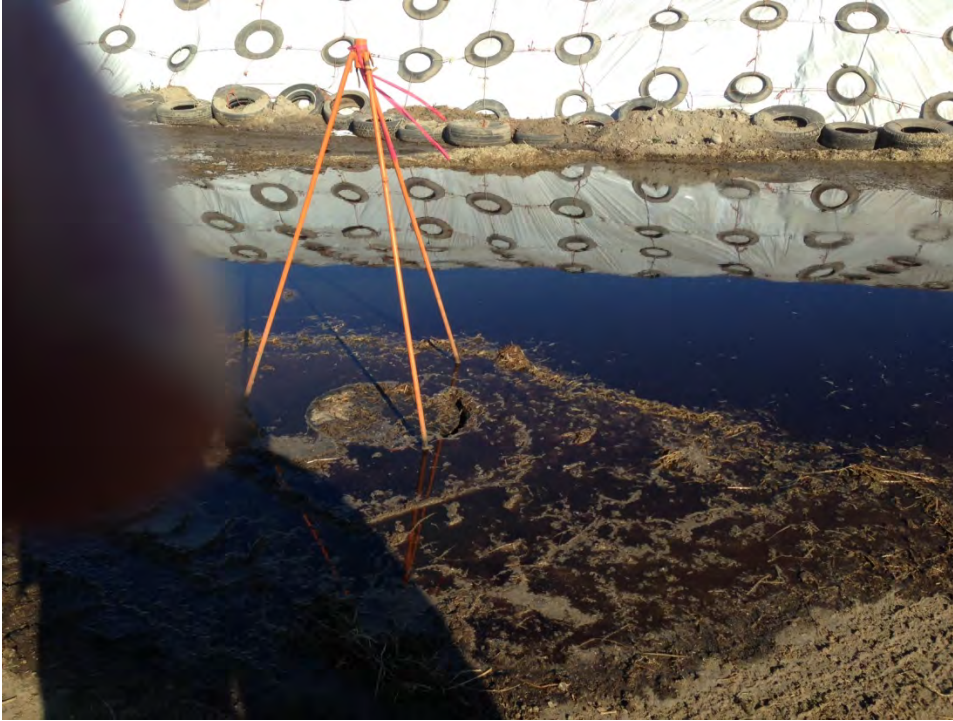
Photo. Silage leachate

128. Given the concentration of nutrients in the acidic leachate from the silage and the fact that this liquid is allowed to run on and into the ground, additional measures should be taken to capture and handle the leachate properly.
